Burbank Water and Power

WILDFIRE MITIGATION PLAN

2024

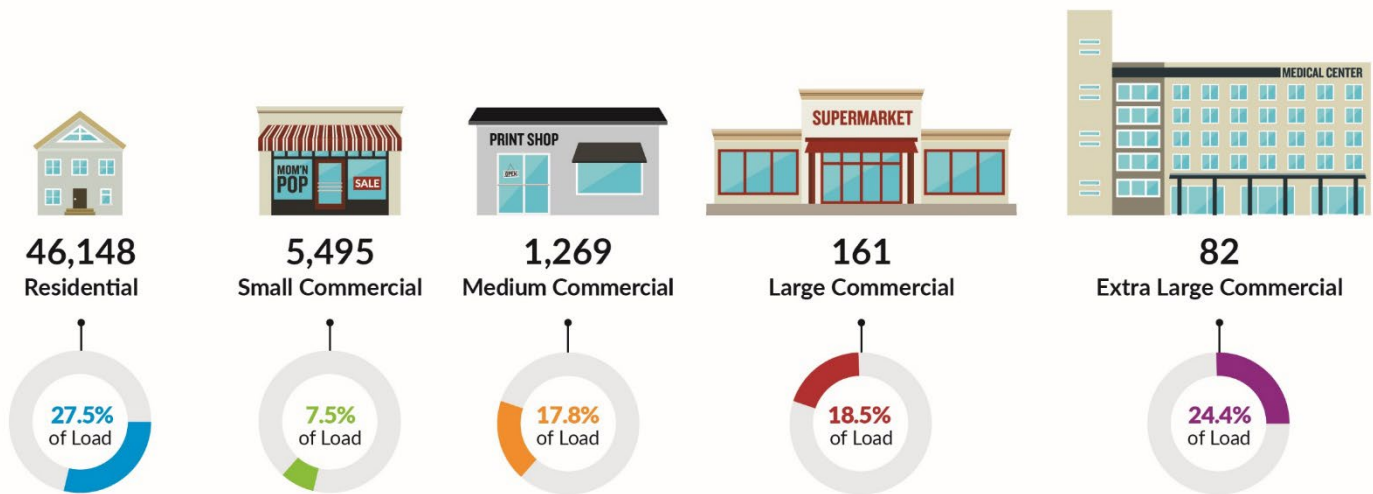
Figure 1 - BWP's electric load

Burbank has a vibrant residential community, with a housing mix of about 18,750 single-family homes that range from post-World War II bungalows to two story view homes. There are about 28,850 multifamily homes. In total, BWP currently serves 46,148 residential, 5,495 small commercial, 1,269 medium commercial, 161 large commercial, and 82 extra-large customer accounts. These customer class counts are the 3-year average through 2022.
